**COKE OVEN CHARGING EMISSION CONTROL
TEST PROGRAM. SUPPLEMENTAL
OBSERVATIONS**

Mitre Corporation

**COKE OVEN CHARGING
EMISSION CONTROL
TEST PROGRAM -
SUPPLEMENTAL OBSERVATIONS**

R. W. Bee and R. W. Spewak

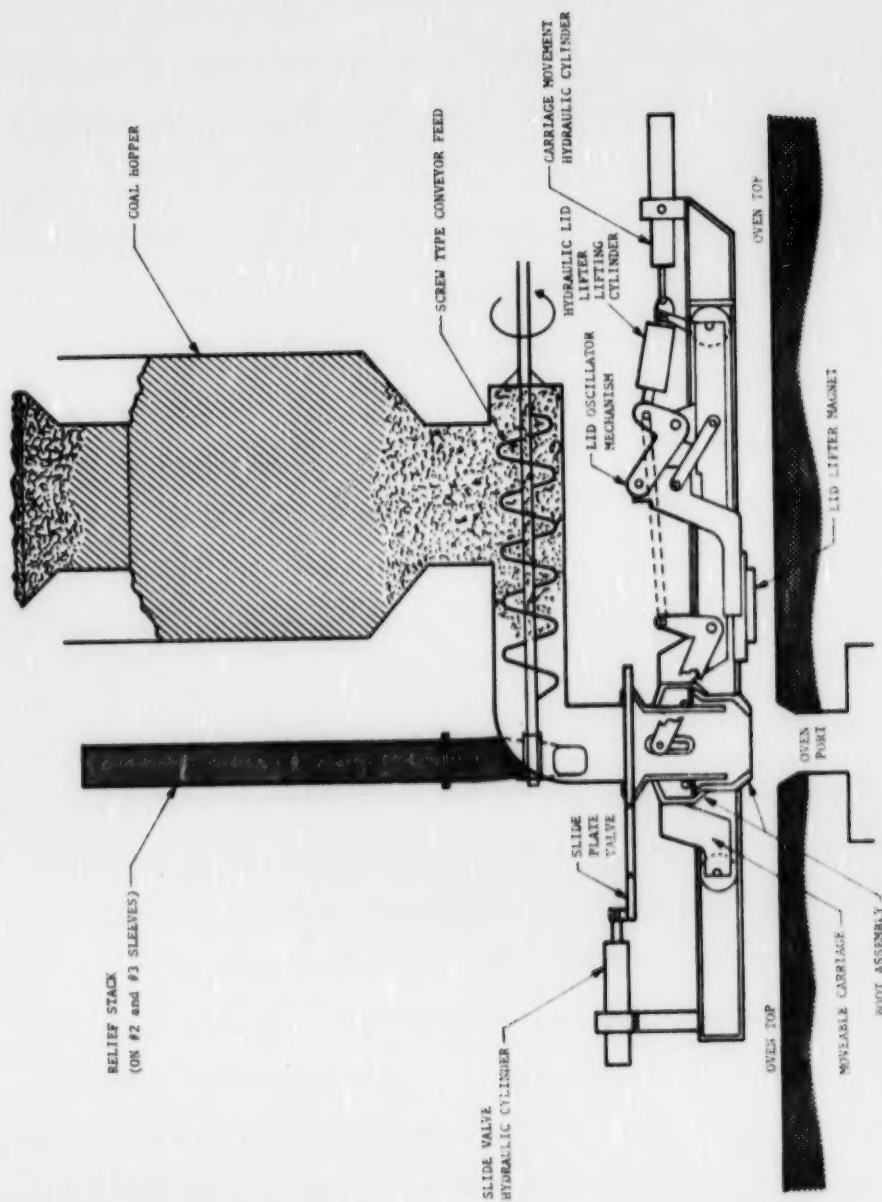
FIGURE 1
WEIRTON CAR ARRANGEMENT

The charging car coal handling system (Figure 1) for each of the four charging sleeves is comprised of a car mounted hopper, a screw type conveyor fed by gravity from the hopper, a "slide plate" valve, a "drop-boot", and a device for mechanically removing and replacing the charging port lids. The significant difference between this coal handling system and the system used on the AISI/EPA car (Figure 2) is the use of the screw conveyor to control the coal flow as opposed to an oscillating "butterfly" valve in the lower portion of the "drop sleeve" on the AISI/EPA car.

The coal is gravity fed from the main hopper to the screw conveyor which can be stopped or started using separate controls in the control cab. The slide valve at the drop sleeve end of the screw conveyor is not used to control the primary coal flow. Its primary function is to seal the drop sleeve after the charge and also to prevent coal tailings from the conveyor tube from falling on the oven surface or the lid lifting mechanism. This arrangement provides a positive coal feed through the screw to a point above the slide plates. From this point, the coal drops loosely through the open slide plate, through the drop sleeve assembly and into the open charging port. In

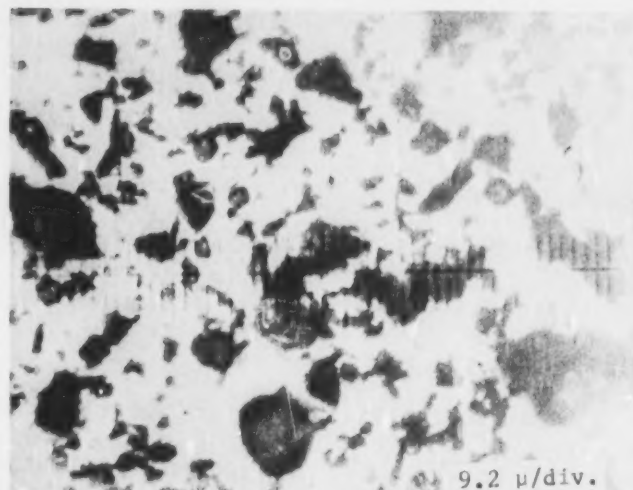
FIGURE 9
TYPICAL AREA OF GREASED SLIDE, CHARGE TO OVEN C-22 ON 3/13

The material deposited on the slides was fairly uniform in size characteristics. An area of one of the greased slides is shown in Figure 9. The deposits, as expected, are concentrated in about a 3/4" circle corresponding to the inlet orifice position and size. Some of the larger particles are located on the periphery of the slide indicating some reentrainment or "particle bounce." Many of the larger particles did not adhere to the slide and were caught in the filter element. This would seem to indicate that although they

impacted on the slide, their larger size and aerodynamic resistance caused them to be dislodged and blown off the greased surface.

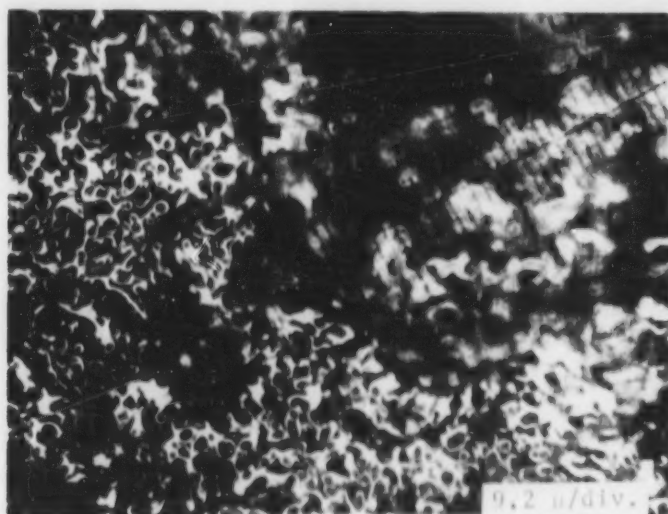
FIGURE 11

Two of the filter elements exhibited a shiny black surface characteristic and fairly heavy sample weights. The surface of the filters as shown in Figure 10 appears to have been wiped with a rather thick liquid. The deposits show a pool like characteristic which produces the shiny surface. This is in contrast to the surface of the other four samples, example in Figure 11, which show a large number of distinguishable particles. The only obvious differences between the two groups of charges was that there was considerably more visible fire on the two tests on which the filters with the shiny surfaces were obtained. The sampler was not operated in the direct flame but the heat may have had a polishing or melt/flow effect on the filters or it may have changed the characteristics of particulate material emitted.

TYPICAL FILTER ELEMENT AREA, CHARGE TO OVEN C-24 ON 3/15/74
